#### AXIOM INSPECTION SERVICES LLC +15746015209 brandt.swihart.ais@gmail.com

### RESIDENTIAL REPORT

1419 North St Logansport, IN 46947

FEBRUARY 1, 2025

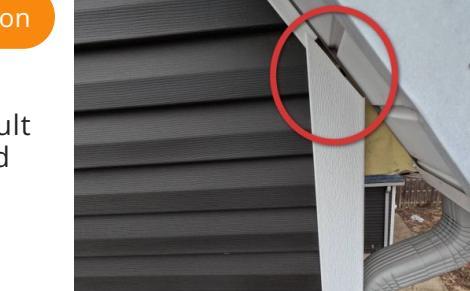
#### FLASHING/TRIM IMPROPERLY INSTALLED

Flashing & trim pieces were improperly installed, which could result in moisture intrusion and damaging leaks. Recommend a qualified siding contractor evaluate and repair.

Contact a qualified siding specialist.

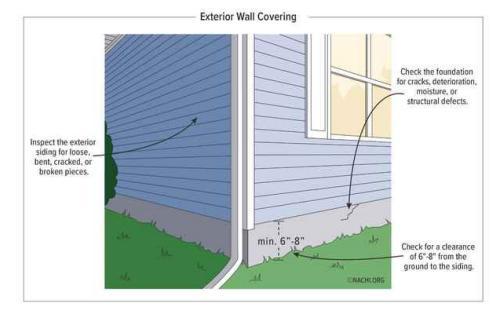
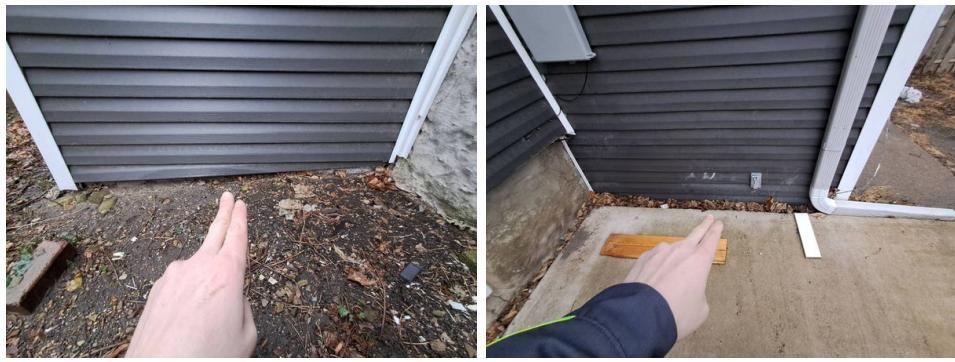
2.2.2 Siding, Flashing & Trim

#### IMPROPER CONSTRUCTION PRACTICES

Siding appears to be installed improperly. Siding clearances from the ground are expected to be a minimum of 6" from grade and 2" from concrete. This could lead to moisture damage or deterioration of the home structure. Recommend a siding specialist evaluate and repair/replace.

Contact a qualified siding specialist.

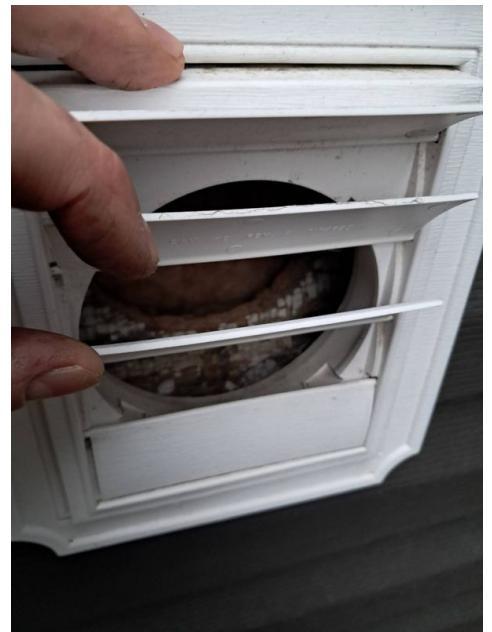
#### 2.2.3 Siding, Flashing & Trim

Old vent louver has been left in place on the South East side of the house, but has been taken out of service. This could allow insects and water to intrude into the interior envelope of the home and could lead to mold, wood rot, and pest infestation. Recommend further evaluation and correction by a qualified contractor.

Contact a qualified siding specialist.

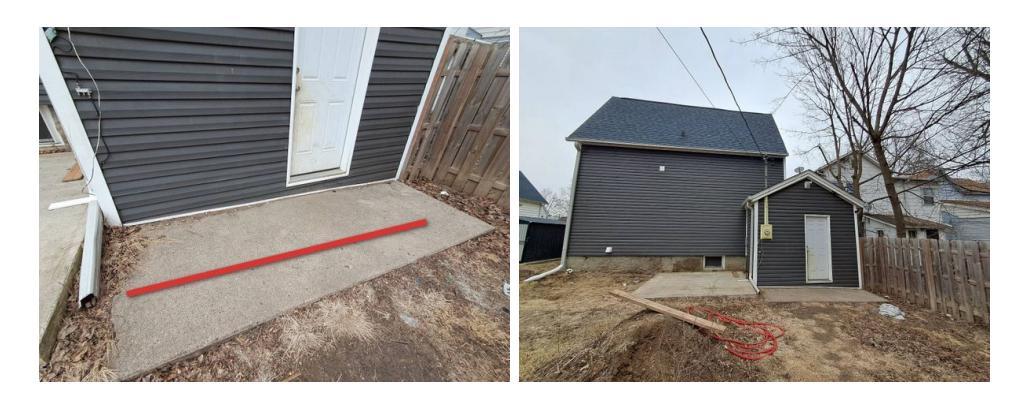
Patio at the back door shows a severe grade to one side possibly indicating past settling. This could cause a slip hazard for residents during inclement weather. Recommend further evaluation and correction by a qualified contractor.

Contact a qualified concrete contractor.

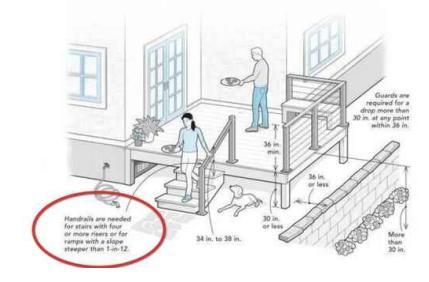
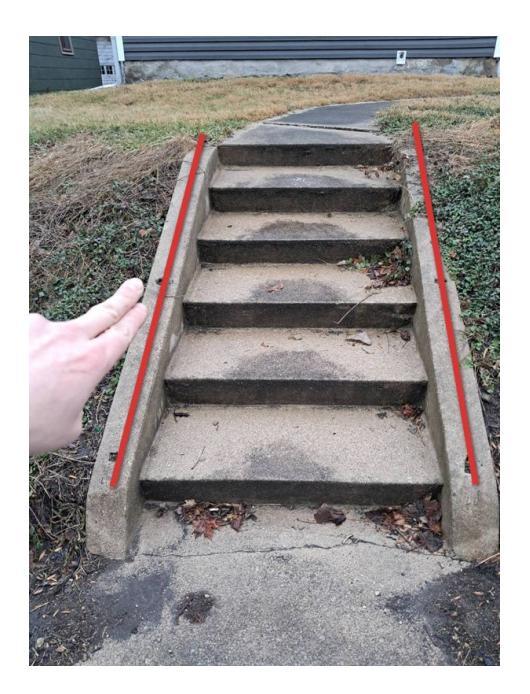
#### 2.4.3 Decks, Balconies, Porches & Steps

#### MISSING HANDRAILS

Front steps to property are missing hand rails. This creates a trip hazard while utilizing the staircase that could contribute to a fall. Recommend correction by a qualified contractor.

Contact a qualified general contractor.

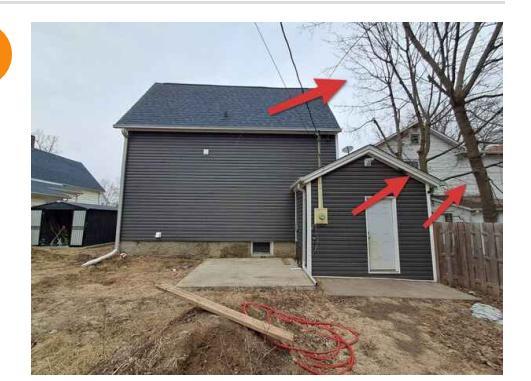
Trees observed overhanging the roof. This can cause damage to the roof and prevent proper drainage of the guttering. Recommend a qualified tree service trim to allow for proper spacing. Will need to monitor this throughout ownership of the property.

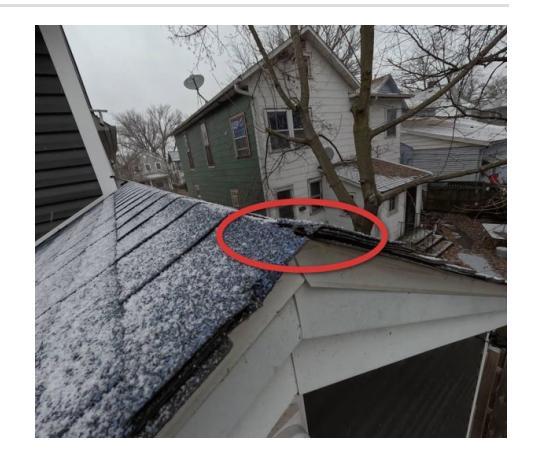
3.1.1 Coverings **DAMAGED (GENERAL)** SOUTH

Roof coverings showed moderate damage. Recommend a qualified roofing professional evaluate and repair.

Recommendation Contact a qualified roofing professional.

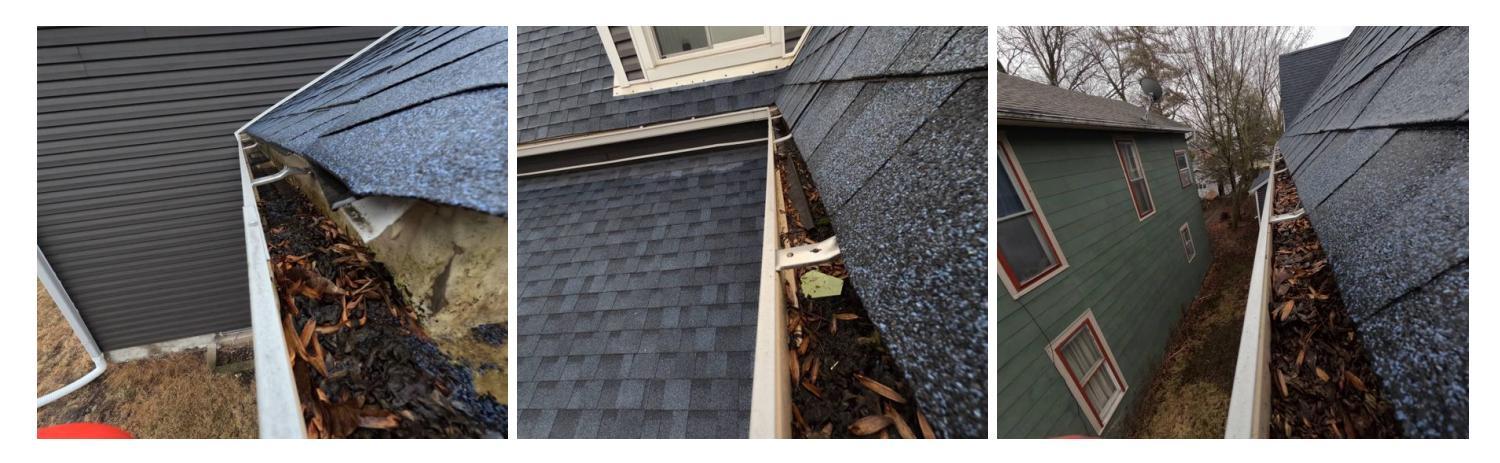
3.2.1 Roof Drainage Systems

#### DEBRIS

Debris has accumulated in the gutters. Recommend cleaning to facilitate water flow. Recommend further evaluation and correction by a qualified contractor.

Contact a qualified gutter contractor

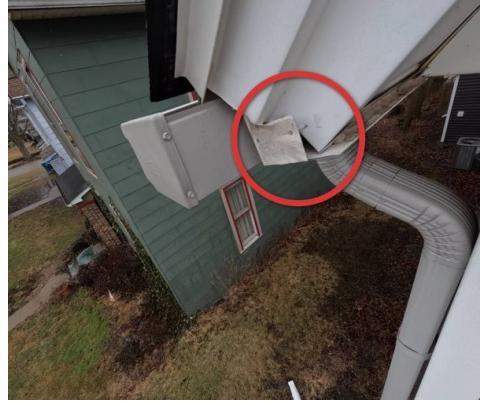
3.3.1 Flashings LOOSE/SEPARATED

Flashings observed to be loose or separated, which can lead to water intrusion and/or mold. Recommend a qualified roofing contractor repair.

Contact a handyman or DIY project

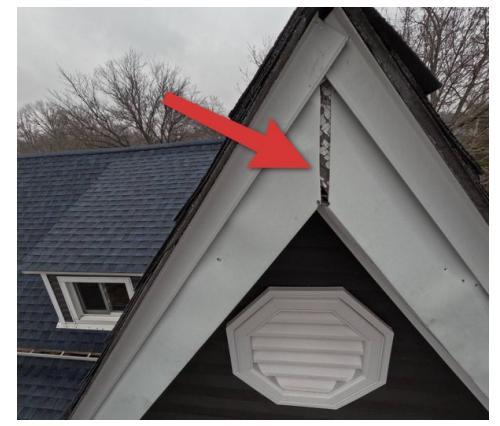
3.3.2 Flashings FLASHING DEFICIENCY WEST

Fascia flashing is not closed off at the top of the western peak. Thus will allow water intrusion and can progress into structural damage to the home, wood rot, & mold. Recommend further evaluation and correction by a qualified contractor.

Contact a qualified roofing professional.

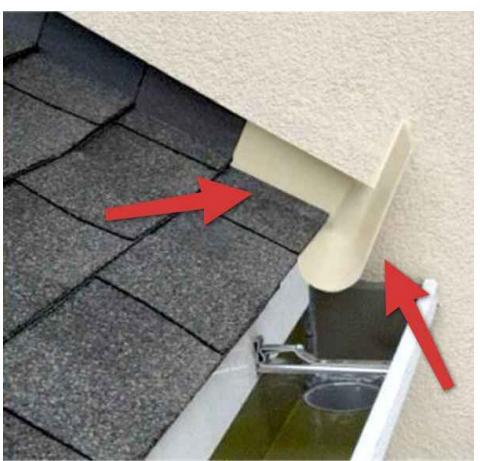
#### 3.3.3 Flashings

#### **MISSING KICKOUT FLASHING**

No kickout flashing installed on the North West end of the covered porch. This will allow water to run along the siding and allow water to get behind the siding and the house instead of being directed into the guttering system. This could lead to structural damage, wood rot, and mold formation. Recommend correction by a qualified contractor.

Contact a qualified roofing professional.

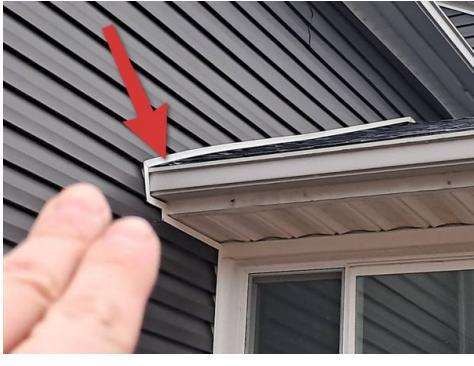
Example of proper kickout flashing

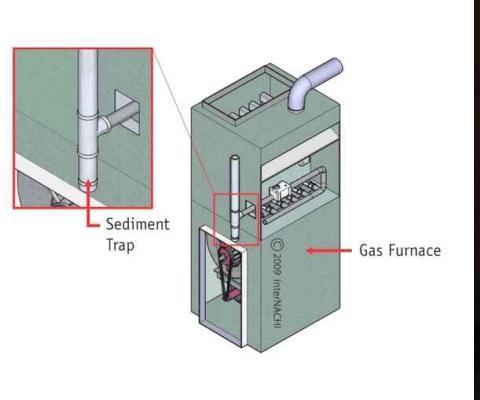
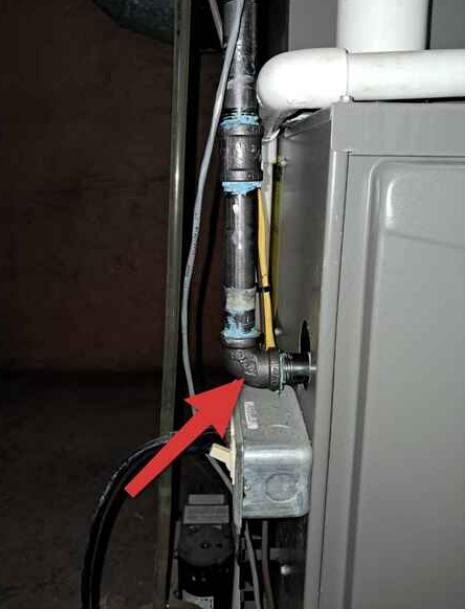
Sediment Trap

#### **MISSING TRAP**

No sediment trap installed on gas supply line. This can allow particulates to enter the HVAC through the fuel source and damage interior components.

Contact a qualified HVAC professional.

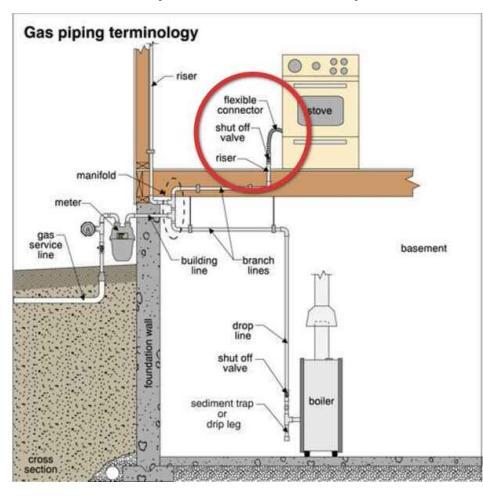
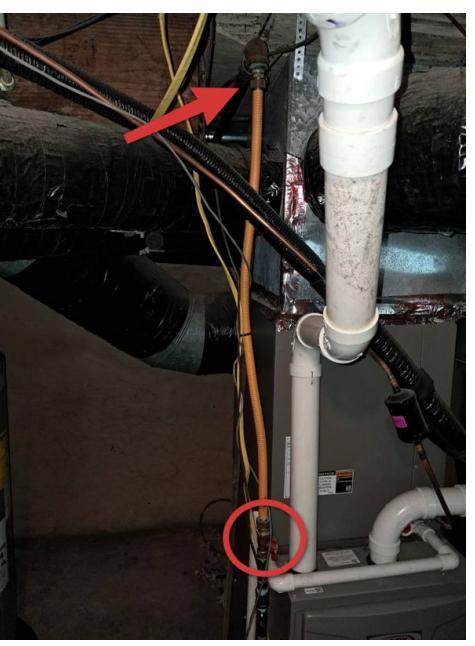
#### 5.1.2 Equipment GAS SHUTOFF DEFICIENCY

Gas shutoff is in the wrong location. Should be installed prior to the flexible gas line as this line is the most likely to suffer damage and cause a leak. This could cause inability to shutoff gas in a hurry should a leak or other issue occur at the furnace.

Contact a qualified HVAC professional.

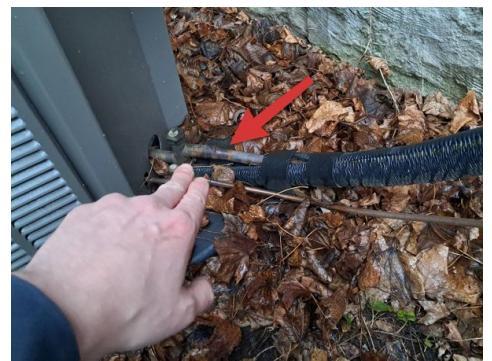
#### **INSULATION MISSING OR DAMAGED**

Missing or damaged insulation on refrigerant line can cause energy loss and condensation. Recommend having the line rewrapped either by means of DIY or a qualified professional.

Recommendation Contact a handyman or DIY project

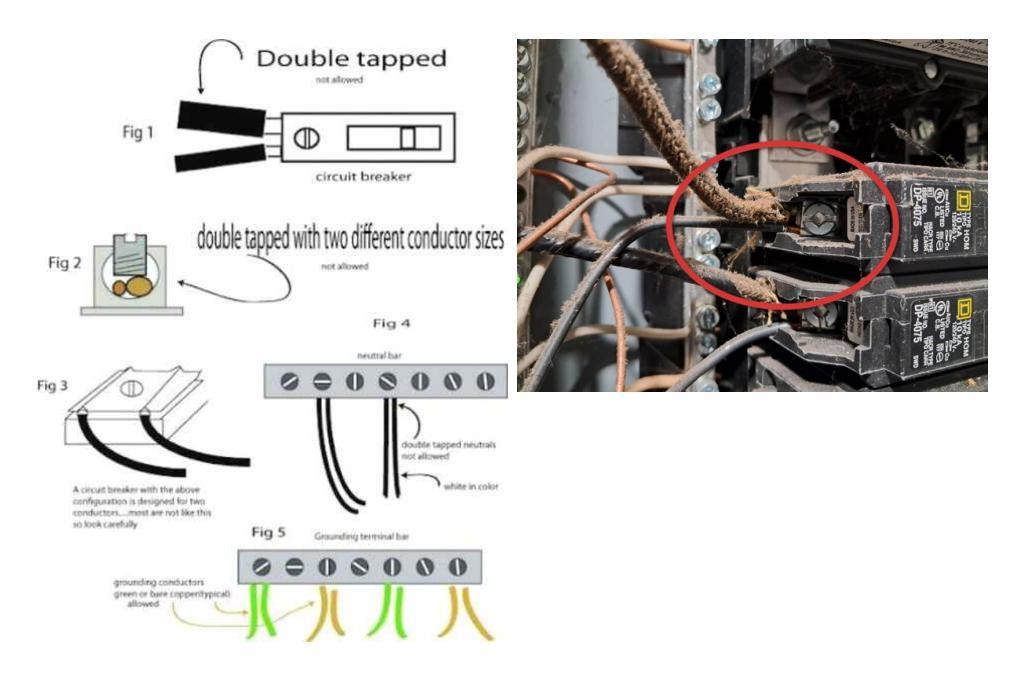
Circuit breaker was incorrectly wired / installed. This indicates that work was probably not performed by a licensed electrician and poses a safety hazard. Recommend that a licensed electrician check the entire panel and repair and replace as need.

Contact a qualified electrical contractor.

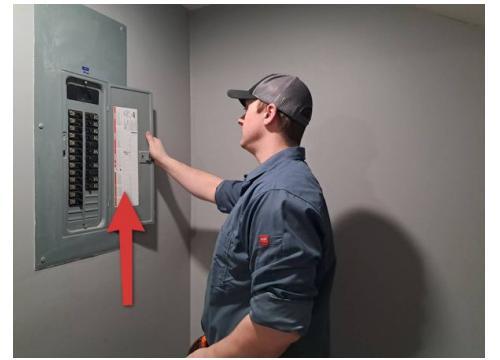
8.2.2 Main & Subpanels, Service & Grounding, Main Overcurrent Device

#### MISSING LABELS ON PANEL

At the time of inspection, panel was missing labeling. Recommend a qualified electrician or person identify and map out locations.

Contact a handyman or DIY project

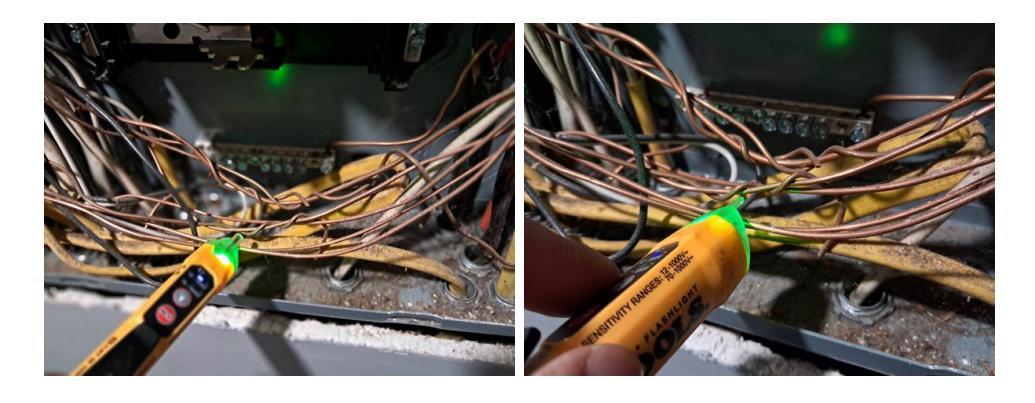
# 8.2.3 Main & Subpanels, Service & Grounding, Main Overcurrent Device **INCORRECTLY GROUNDED CIRCUITS.**

Many circuit grounds are incorrectly landed and are tied to an existing ground. This does not guarantee a good contact with ground and could pose a risk to electric shock and fire. Recommend further evaluation and correction by a qualified contractor.

Contact a qualified electrical contractor.

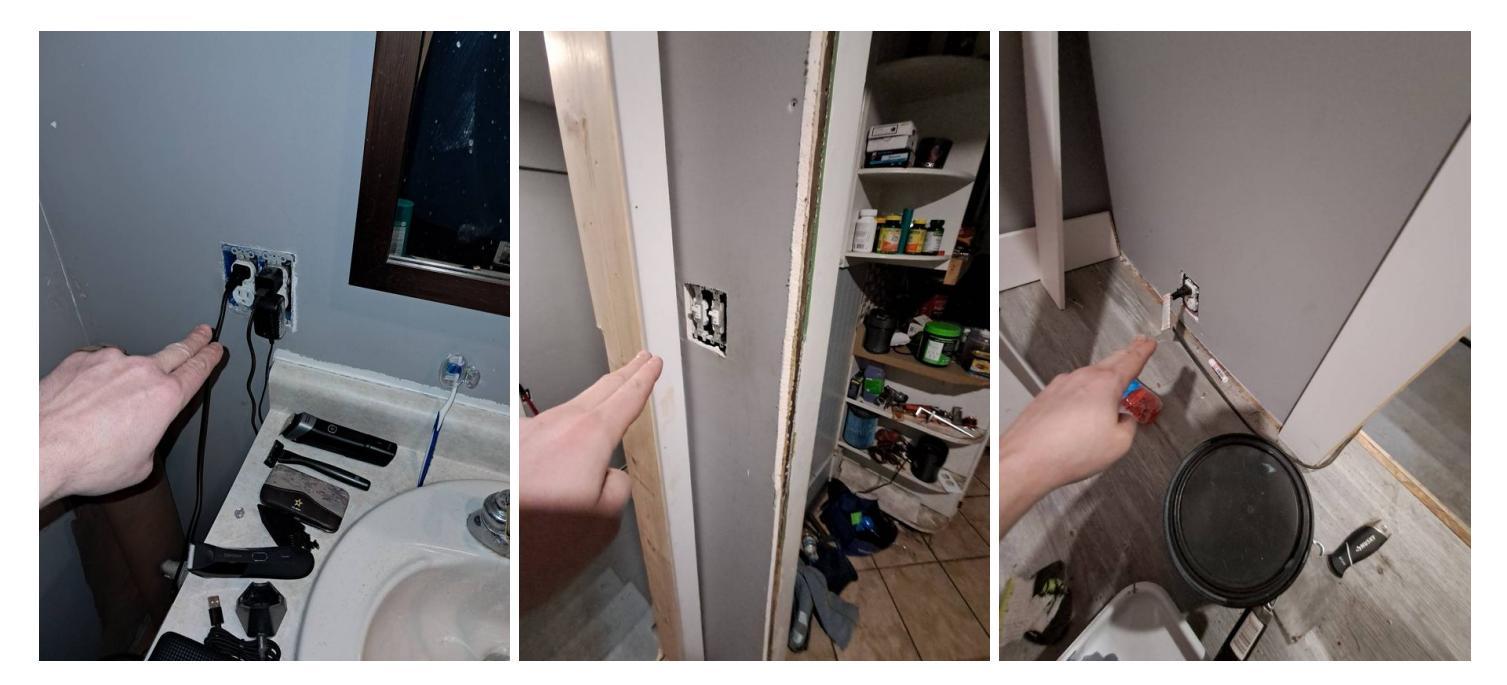
8.4.1 Lighting Fixtures, Switches & Receptacles

#### **COVER PLATES MISSING**

One or more receptacles are missing a cover plate. This causes short and shock risk. Recommend installation of plates by a qualified contractor.

Contact a handyman or DIY project

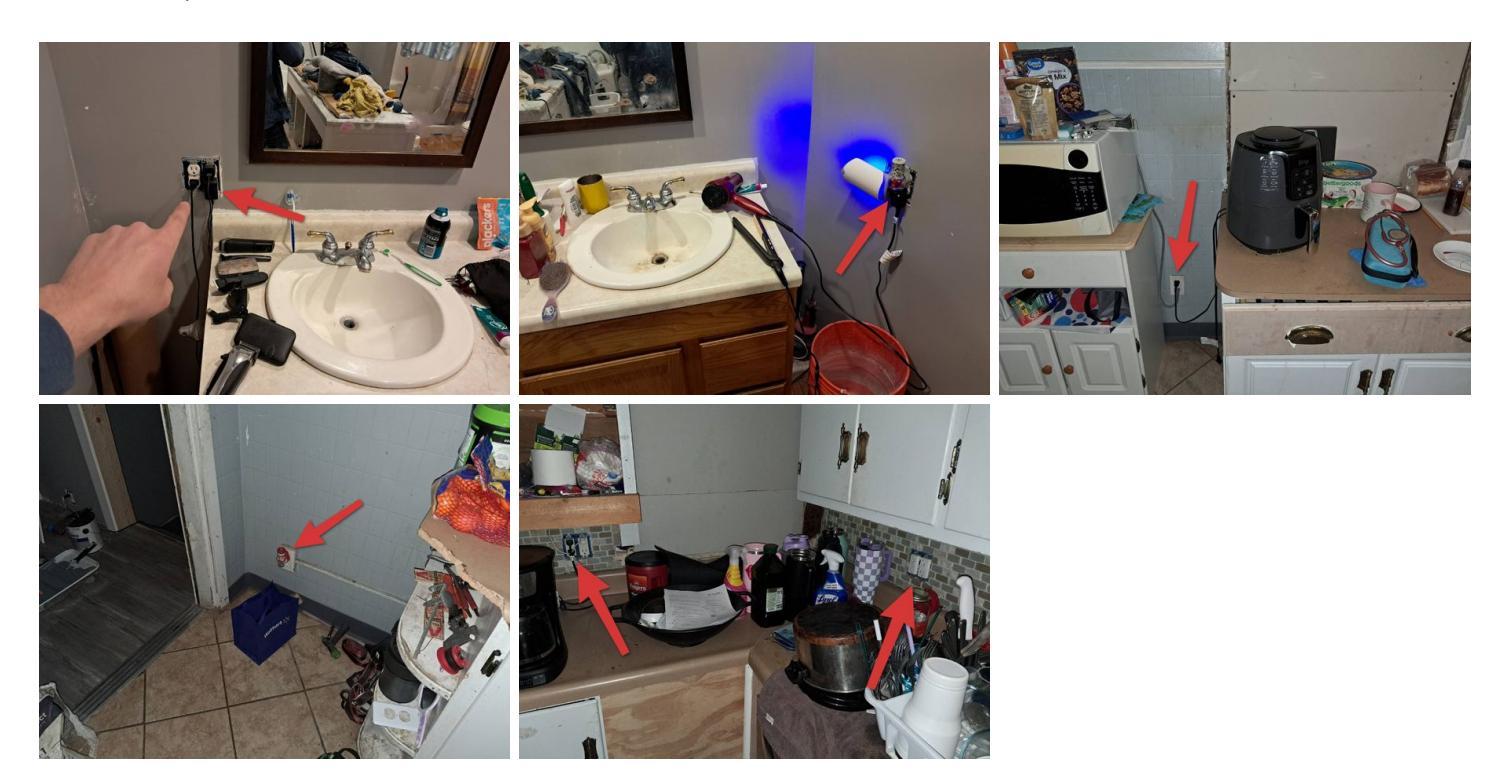
#### 8.5.1 GFCI & AFCI

#### NO GFCI PROTECTION INSTALLED

No GFCI protection present in all locations. Recommend licensed electrician upgrade by installing ground fault receptacles in all locations.

#### Contact a qualified electrical contractor.

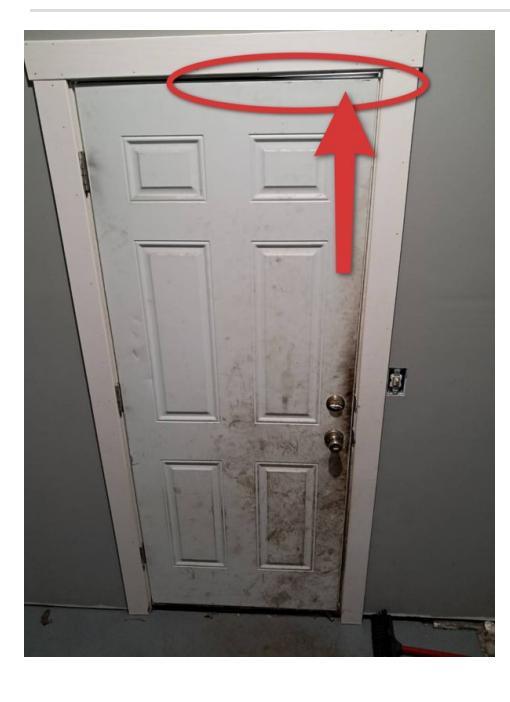
One or more gaps could result in energy loss. Recommend handyman or door contractor evaluate. Recommendation Contact a qualified door repair/installation contractor.

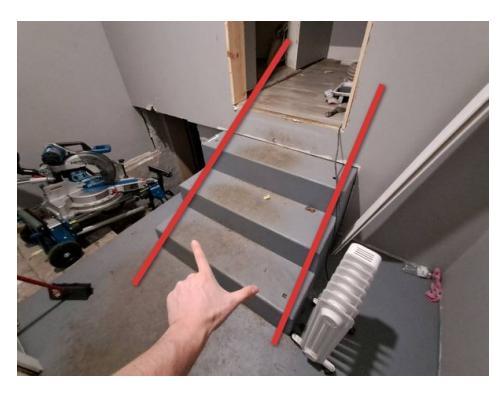
10.6.1 Steps, Stairways & Railings **NO HANDRAIL**

Staircase just inside the rear door had no handrails. This is a safety hazard and could result in a fall injury if not corrected. Recommend a qualified handyman install a handrail.

Recommendation Contact a qualified handyman.

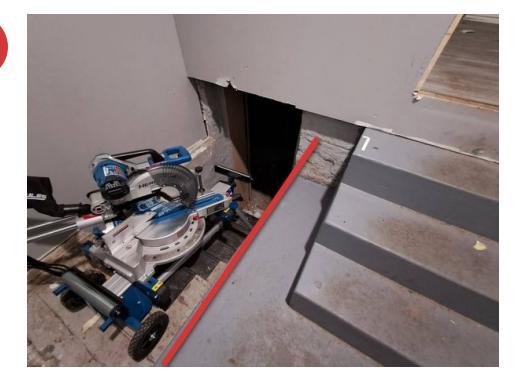
#### 10.6.2 Steps, Stairways & Railings **NO HAND RAIL**

No hand rail between the basement steps and landing. Hand rail is required for any drop exceeding 30". This could result in a fall injury if not corrected. Recommend further evaluation and correction by a gualified contractor.

Recommendation Contact a qualified handyman. Safety Hazard

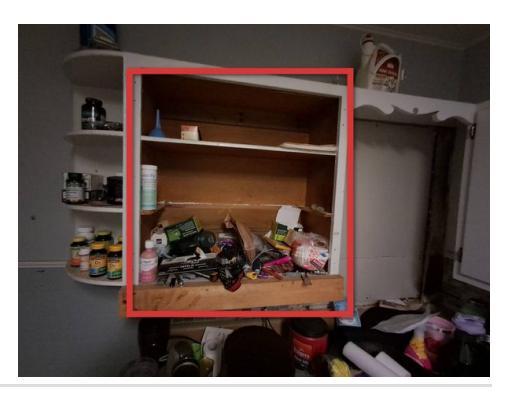
10.7.1 Countertops & Cabinets

## CABINET DOOR MISSING

One or more cabinet doors were missing.

Contact a qualified cabinet contractor.

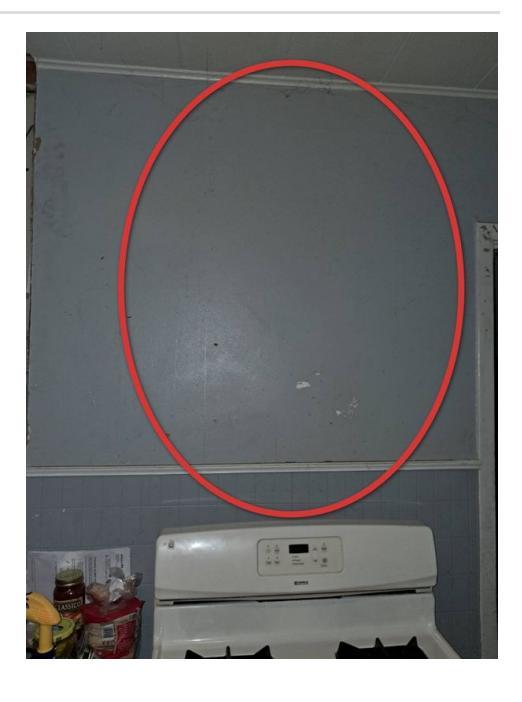
11.3.1 Range/Oven/Cooktop **EXHAUST SYSTEM MISSING**

No exhaust system present to prevent moisture and grease in kitchen area. Recommend qualified contractor install range hood or exhaust system.

Contact a qualified general contractor.

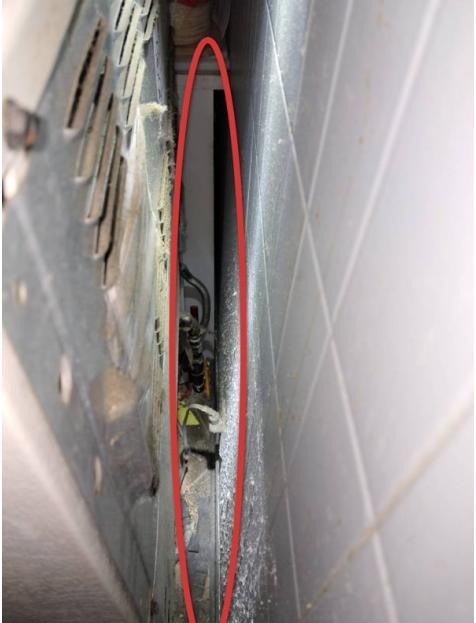
#### 11.3.2 Range/Oven/Cooktop

#### RANGE NOT FASTENED KITCHEN

Range was not fastened to the floor or wall. This poses a safety hazard to children. Recommend a qualified contractor secure range so it can't tip.

Recommendation Contact a qualified handyman.

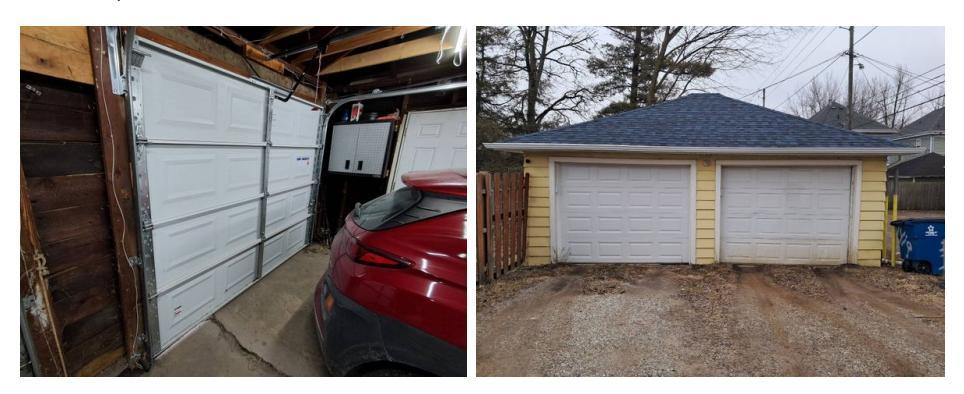
North garage door was in good working condition at the time of inspection. All signage present. All safety devices functioning as intended. Door has an incomplete seal at the bottom due to uneven concrete surfaces.

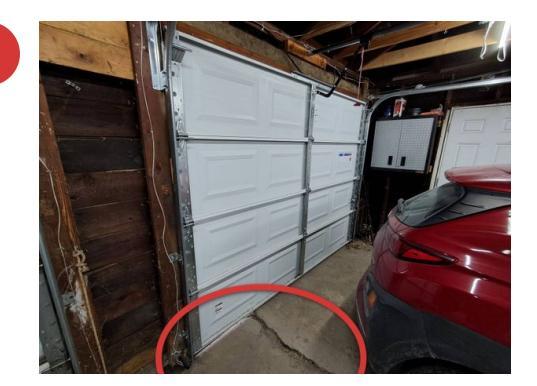
Garage floor shows signs of settling in the soil beneath the slab. Recommend a structural engineer evaluate for potential repairs.

Contact a qualified structural engineer.

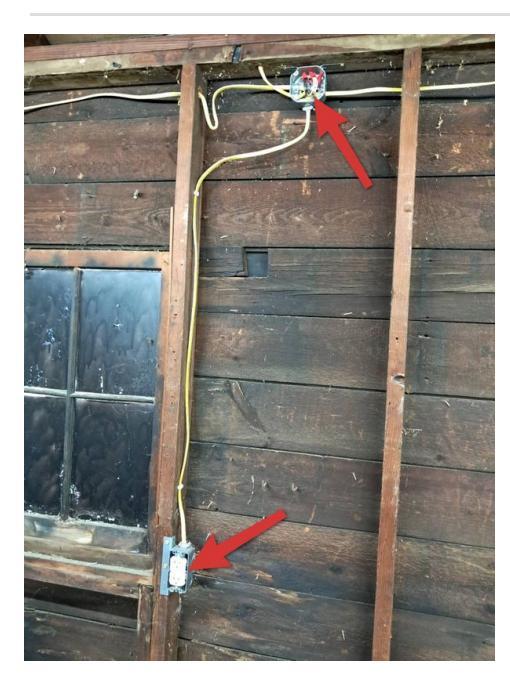
#### 12.3.1 Walls & Firewalls

#### **OPEN ELECTRICAL OUTLETS**

Electrical outlets and J-boxes are without covers. This could allow energized components to be contacted by individuals interacting with the object and lead to potentially fatal electric shock. Recommend further evaluation and correction by a qualified contractor.

Recommendation Contact a qualified electrical contractor.

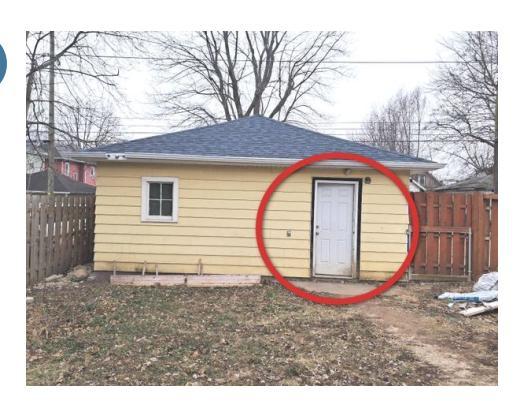
#### 12.7.1 Occupant Door

### DOES NOT LATCH

Occupant door cannot be securely latched. Due to improper installation. Recommend further evaluation and correction by a qualified contractor.

Contact a qualified door repair/installation contractor.

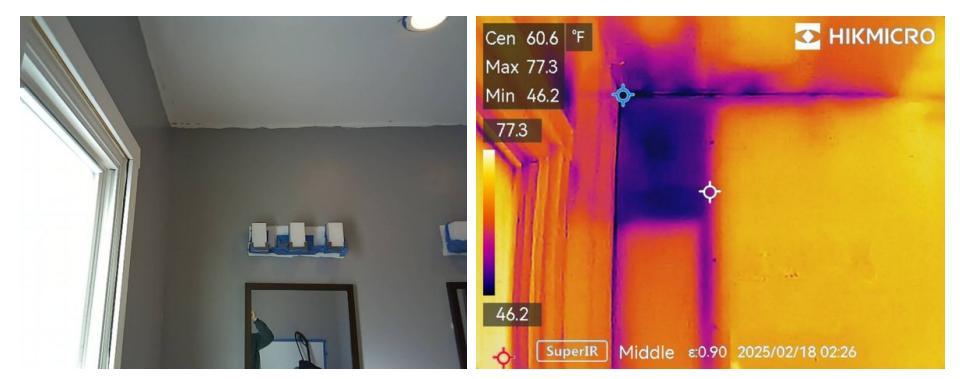
Missing insulation on the exterior facing wall. Need to apply adequate insulation to eliminate an area where condensation can form. This can lead to water damage, wood decay, and mold growth. No moisture detected, but better air sealing measures recommended. Refer to a qualified contractor for further evaluation.

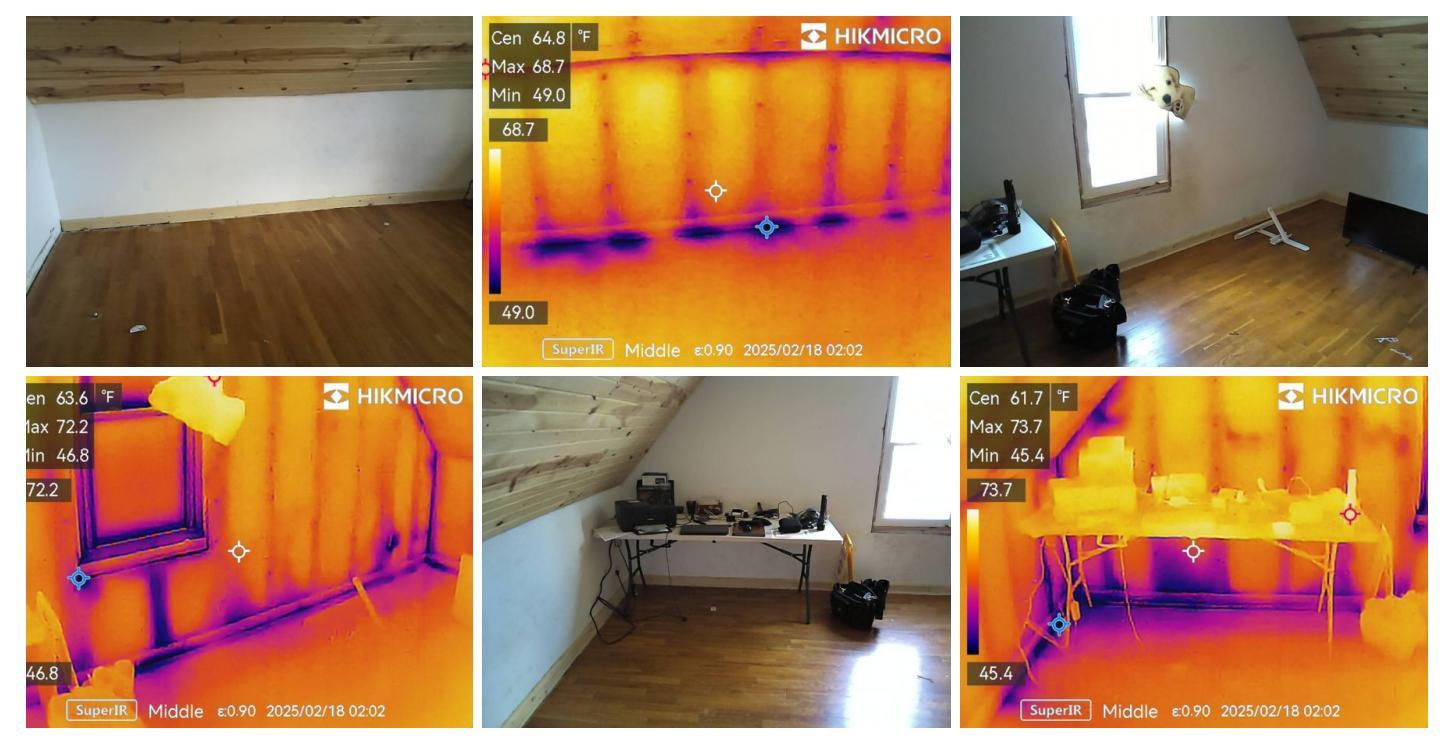
2nd Floor North Bedroom

Some signs of air intrusion at the corners of the room. No moisture detected, but better air sealing measures recommended. Refer to a qualified contractor for further evaluation.

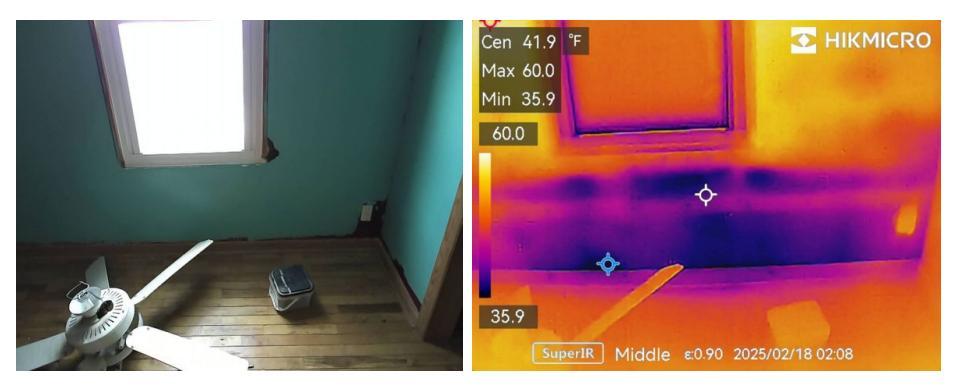
2nd Floor South East Bedroom

Missing insulation on the exterior facing walls. Need to apply adequate insulation to eliminate an area where condensation can form. This can lead to water damage, wood decay, and mold growth. No moisture detected, but better air sealing measures recommended. Refer to a qualified contractor for further evaluation.

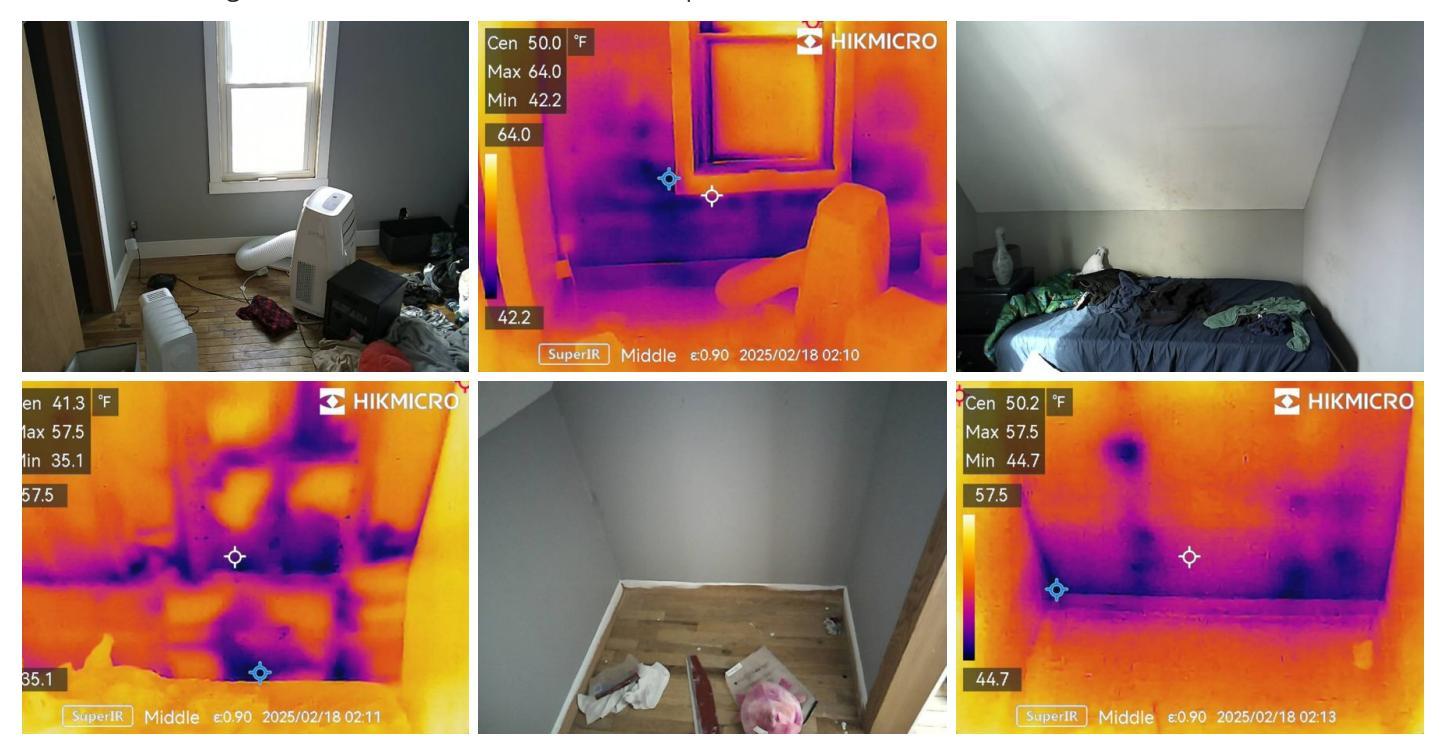
2nd Floor South West Bedroom

Missing insulation on the exterior facing walls. Need to apply adequate insulation to eliminate an area where condensation can form. This can lead to water damage, wood decay, and mold growth. No moisture detected, but better air sealing measures recommended. Refer to a qualified contractor for further evaluation.

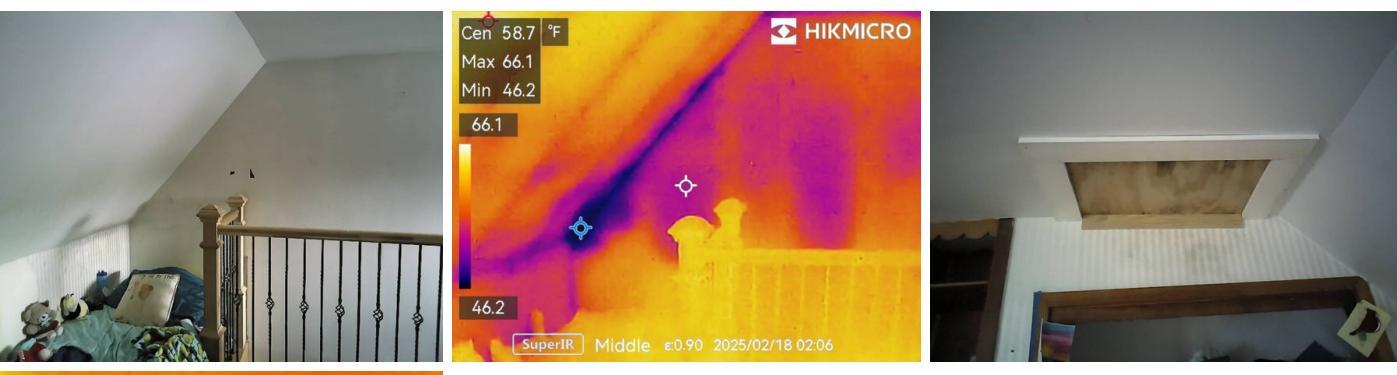
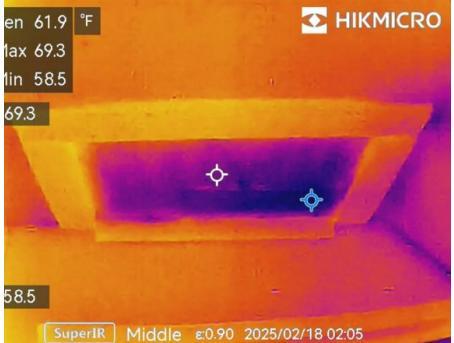
2nd Floor

Missing insulation on the back of the attic access door. Need to apply adequate insulation to the door to eliminate an area where condensation can form. This can lead to water damage, wood decay, and mold growth. No moisture detected, but better air sealing measures recommended. Refer to a qualified contractor for further evaluation.

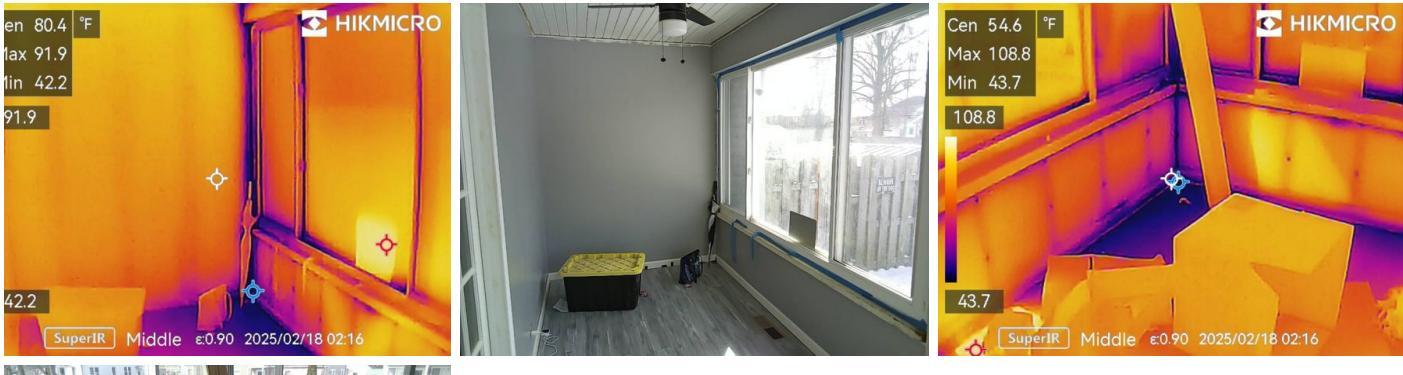
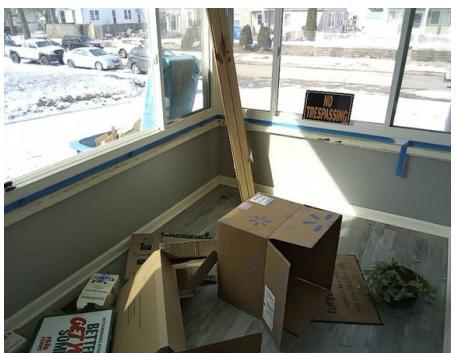
1st Floor West Porch

Front porch showed some signs of air intrusion at the 90 degree connections. No moisture detected, but better air sealing measures recommended. Refer to a qualified contractor for further evaluation.

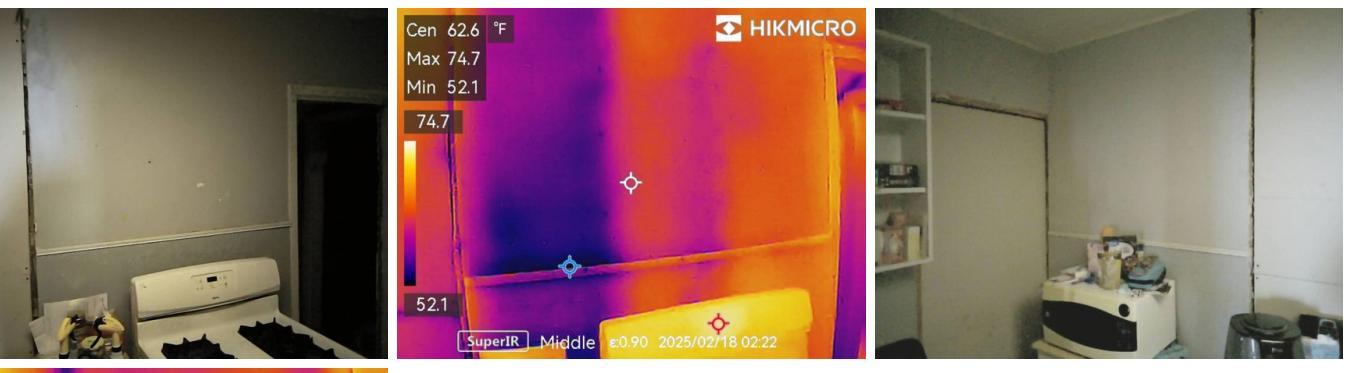
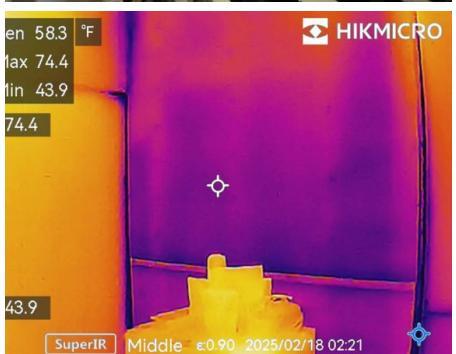
1st Floor Kitchen

Thermal imaging revealed missing insulation in the exterior kitchen walls. Need to adequate insulation installed to eliminate an area where condensation can form. This can lead to water damage, wood decay, and mold growth. No moisture detected, but better air sealing measures recommended. Refer to a qualified contractor for further evaluation.

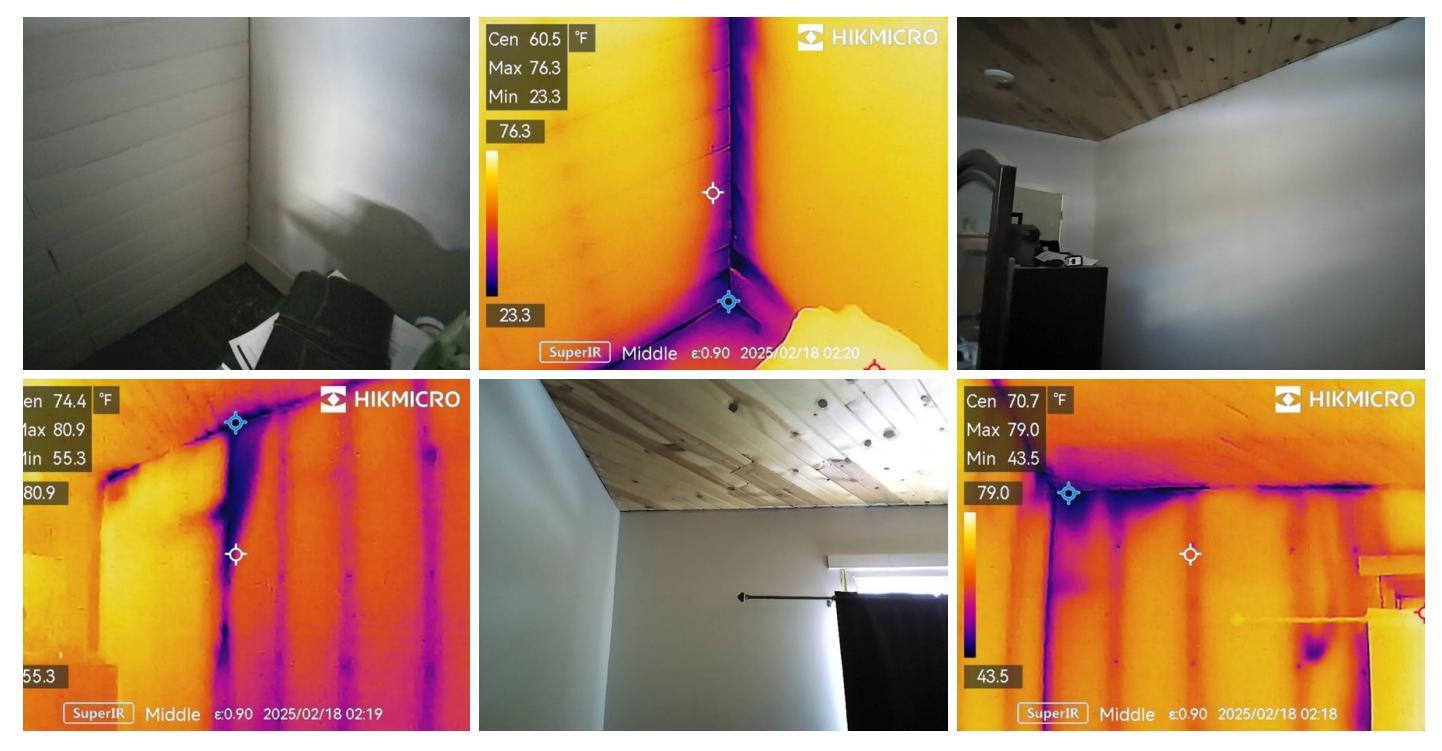
#### Master bedroom: Master bedroom imaging 1st Floor North Master Bedroom

Some signs of air intrusion at the corners of the room and where the porch meets the outer envelope of the home. No moisture detected, but better air sealing measures recommended. Refer to a qualified contractor for further evaluation.
